Contract #: 04-0120F4Cty: SF/ALA Rte: 80 PM: 13.2/13.9File #: 69.28**WELDING INSPECTION REPORT****Resident Engineer:** Pursell, Gary**Address:** 333 Burma Road**City:** Oakland, CA 94607**Report No:** WIR-015076**Date Inspected:** 21-Jun-2010**Project Name:** SAS Superstructure**OSM Arrival Time:** 700**Prime Contractor:** American Bridge/Fluor Enterprises, a JV**OSM Departure Time:** 1900**Contractor:** Zhenhua Port Machinery Company, Ltd (ZPMC), Changxing Island **Location:** Shanghai, China**CWI Name:****CWI Present:****Yes No****Inspected CWI report:** **Yes No N/A****Rod Oven in Use:** **Yes No N/A****Electrode to specification:** **Yes No N/A****Weld Procedures Followed:** **Yes No N/A****Qualified Welders:** **Yes No N/A****Verified Joint Fit-up:** **Yes No N/A****Approved Drawings:** **Yes No N/A****Approved WPS:** **Yes No N/A****Delayed / Cancelled:** **Yes No N/A****Bridge No:** 34-0006**Component:** OBG Trial Assembly**Summary of Items Observed:**

Orthotropic Box Girder (OBG) Trial Assembly Areas

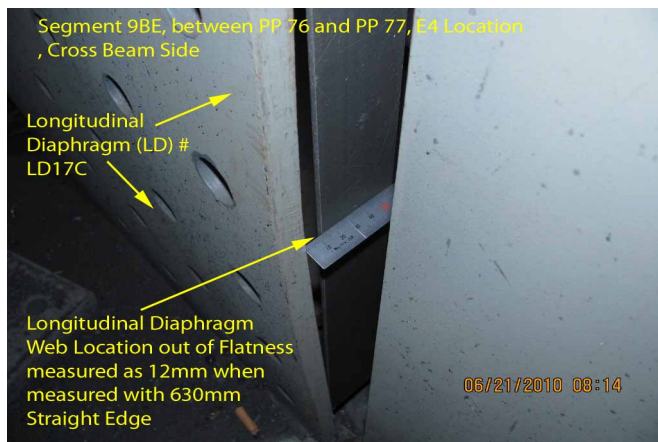
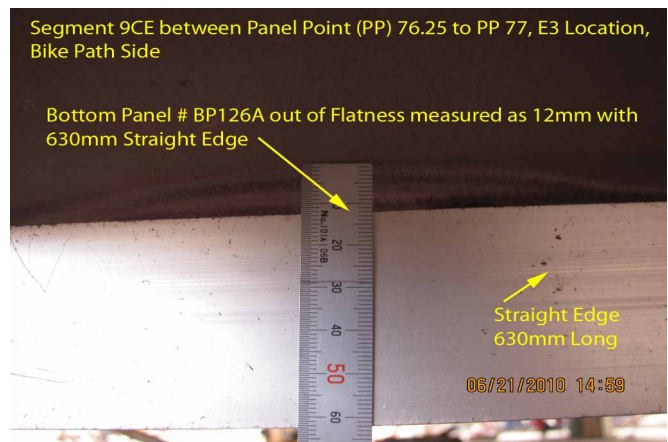
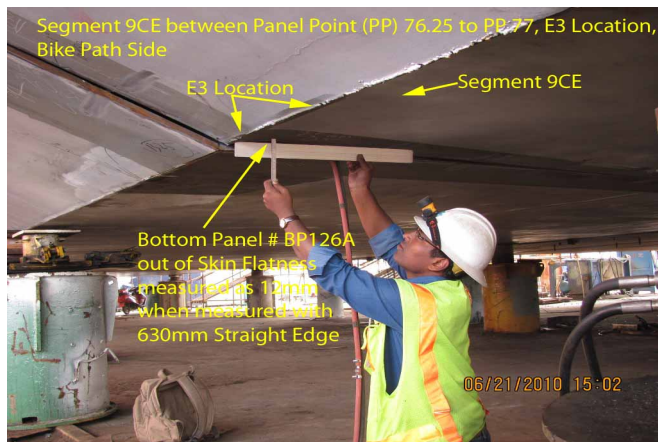
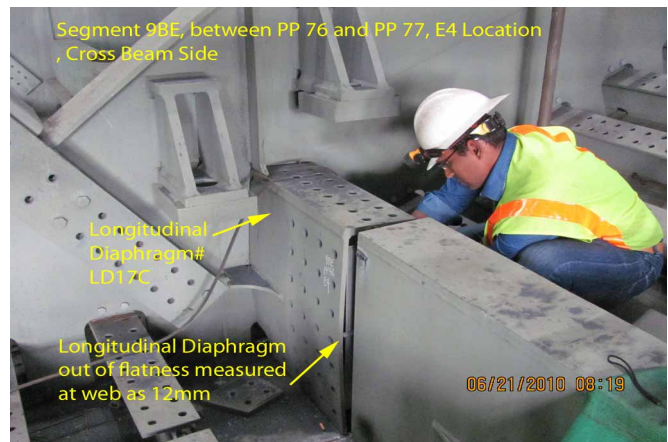
This Quality Assurance (QA) Inspector wrote an Incident Report for Out of Flatness for Longitudinal Diaphragm Web at E4 Location for Segment 9BE between Panel Point (PP) 76 to PP 77 for more comprehensive details please refer the Incident Report 04-0120F4_TL-15_B278_06-21-2010_Longitudinal Diaphragm_Distorted_9BE between PP 76 and PP 77 Dated June 20, 2010. Please refer the attached pictures for more comprehensive details.

This Quality Assurance (QA) Inspector wrote an Incident Report for Out of Flatness for Bottom Panel E3 Location for Segment 9CE between Panel Point (PP) 76.25 to PP 77 for more comprehensive details please refer the Incident Report 04-0120F4_TL-15_B278_06-21-10_9CE_Out of Flatness_Bottom Panel_between PP 76.25 to PP77 Dated June 21, 2010. Please refer the attached pictures for more comprehensive details.

This QA Inspector observed during random visual Inspection at Segment 7BW and 7DW at PP 50, PP 51, PP 57, PP 58 at Work Point W4, East side of the Floor Beam that Bottom Panel T-Rib Clip is been welded to Floor Beam as Drilled hole at Clips and Floor Beam are mis-matched till 5mm. The work is been performed against the ABF RFI # ABF-RFI-001758R00 Dated May 19, 2009.
